## **Appendix C: Worst Performing Circuit Inspections**

### **Worst Performing Circuit Inspections:**

### **Staff Observations – Monday June 13, 2005**

ComEd Chicago Region

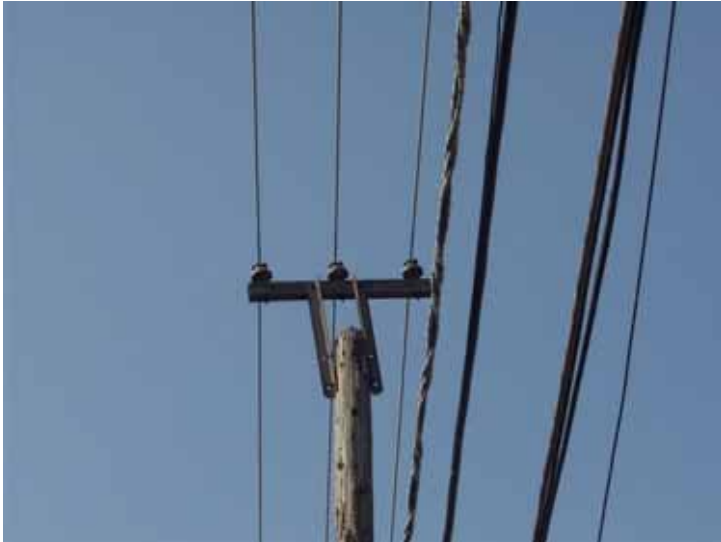
P6130008 – shoes on center phase hanging down to xfmr tap and very close to touching tap

ComEd personnel present with Staff called in to have shoes removed.

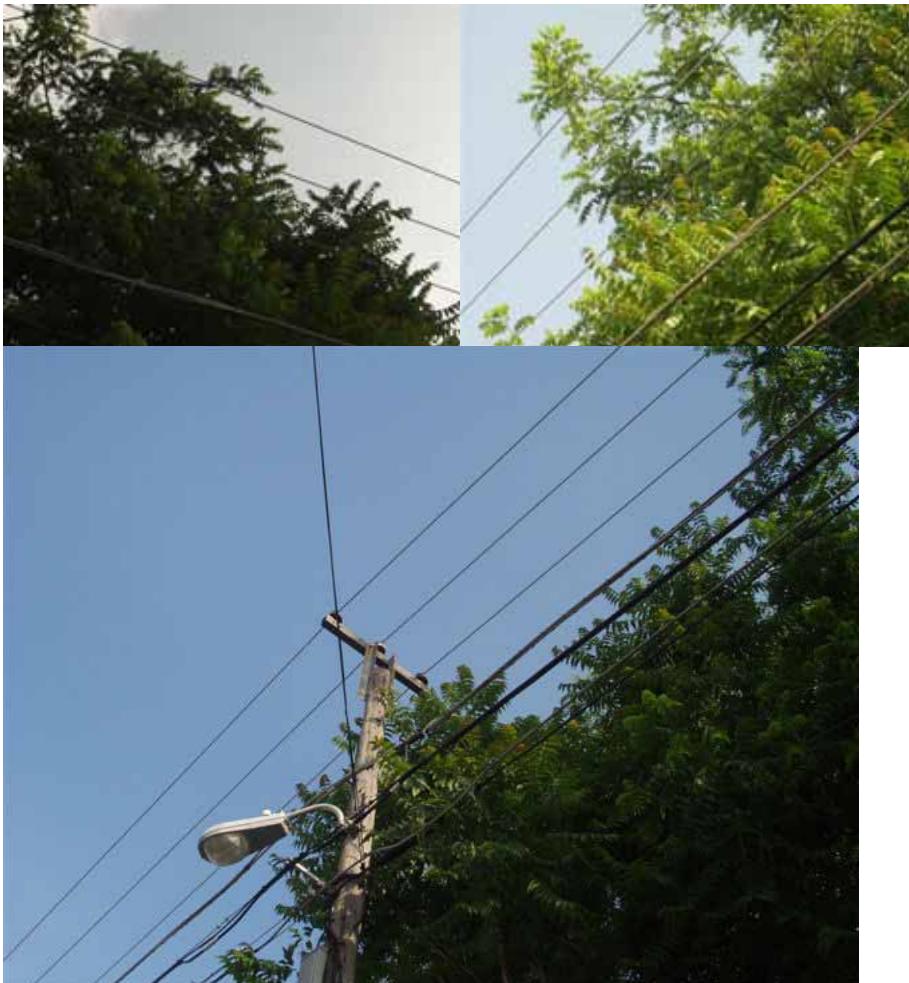
P6130009 – Loose pole top extension.

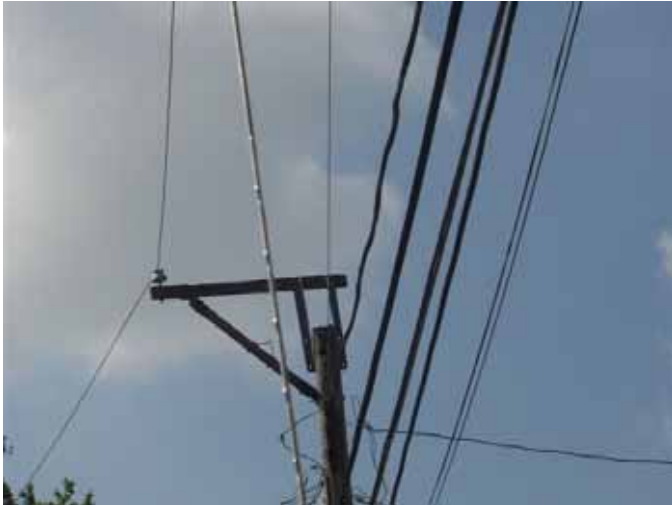
P6130021 – Pole Top Extension appears loose – looks like a loose bolt.

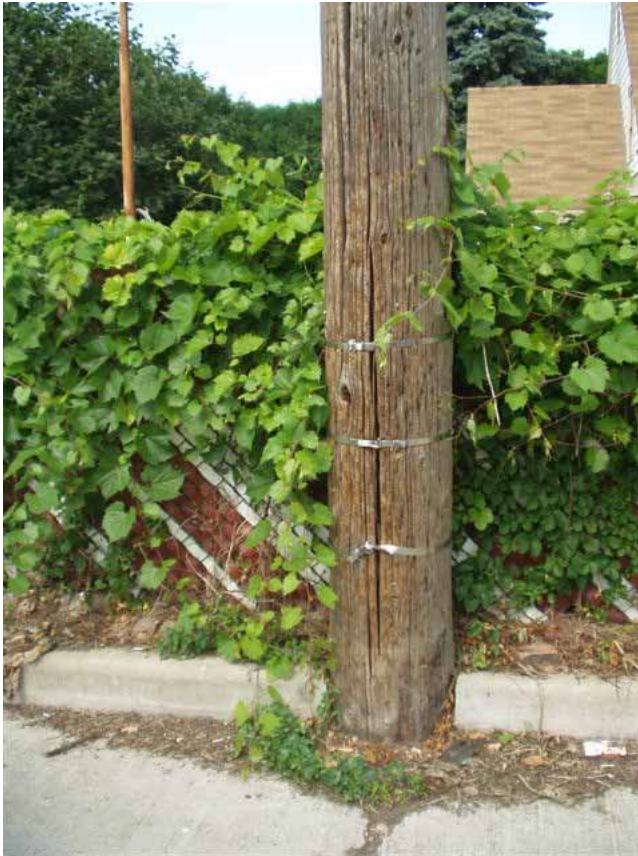
P6130022 – Customer came out during inspection and told Staff that the Pole made “cracking sounds” near the base when the wind blows. Several questionable poles as well as ragged pole tops were noted by Staff North of this position in alley. ComEd personnel present with Staff called this in to their respective offices.

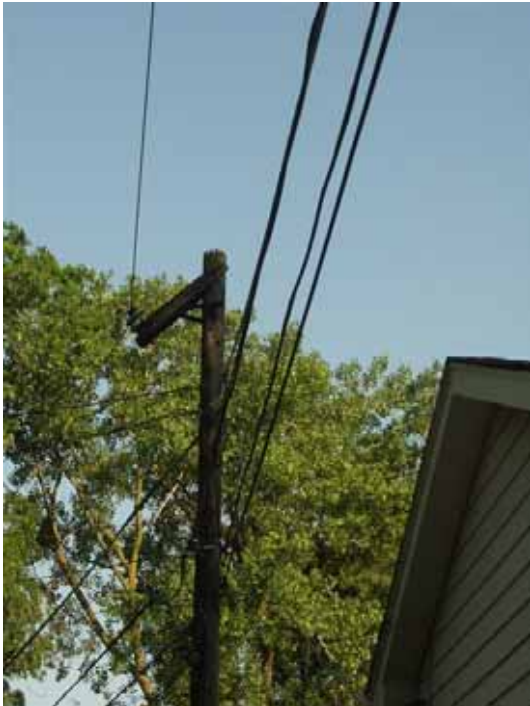
P6140032 – Broken cross arm support. Pole top also ragged.

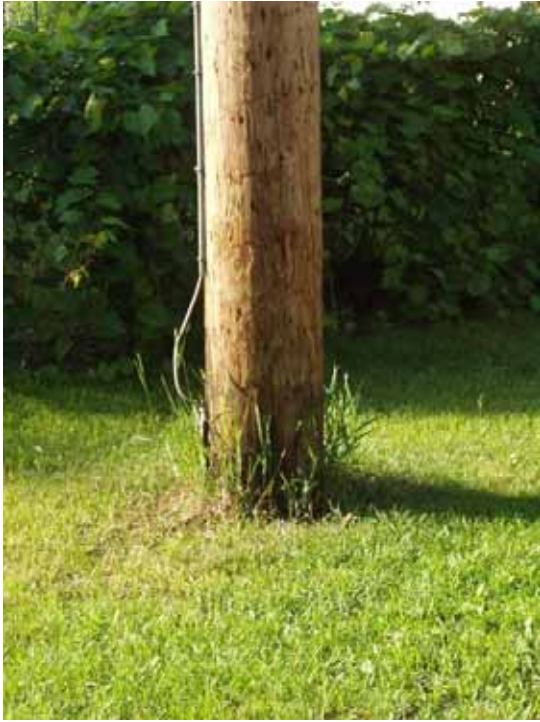
P6140033 – Exposed ground wire – cover molding is broken off & and ground wire is pulled away from pole

Top of pole appears questionable -- Located about a block east from this pole another questionable pole was seen – “iffy” but may still be sound.

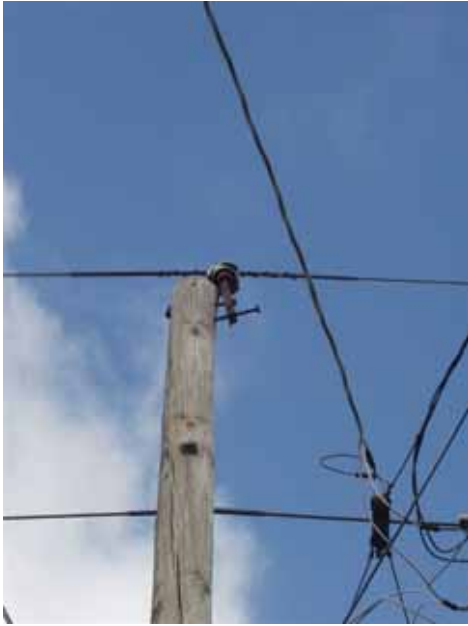
P6140036 – broken insulator and pole top pin coming off pole, bottom bolt nearly out.

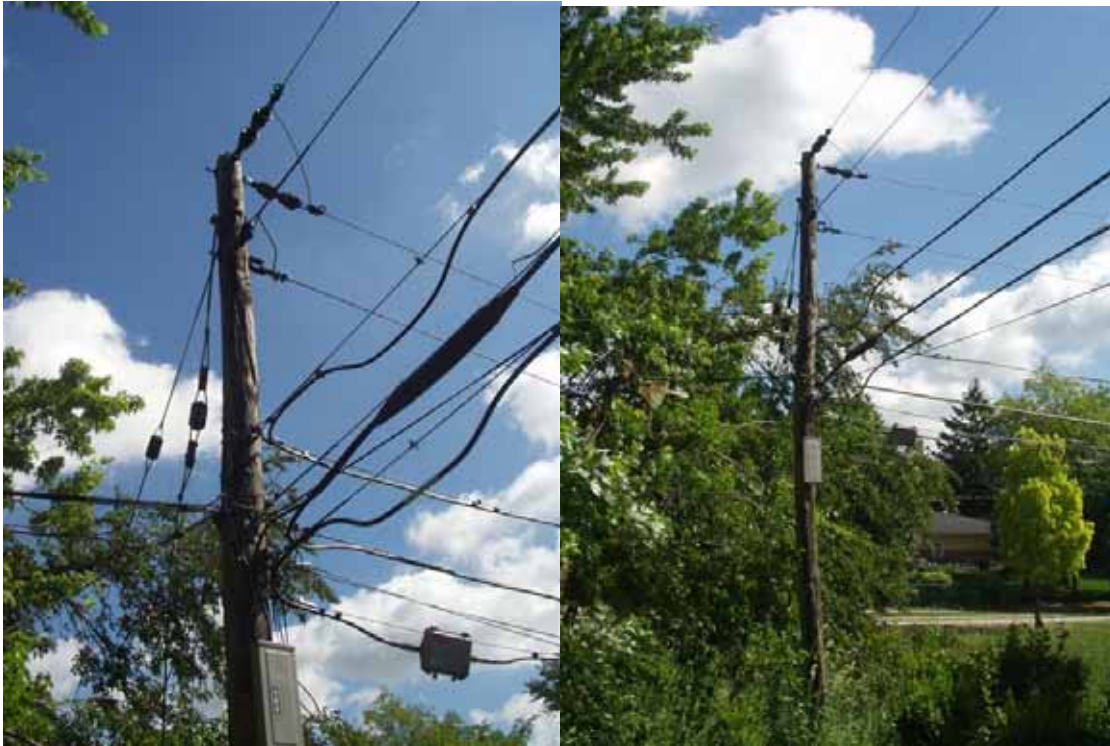
P6140043 & P6140044 – pole looks questionable. 2 damaged down guys and guy guards are missing.

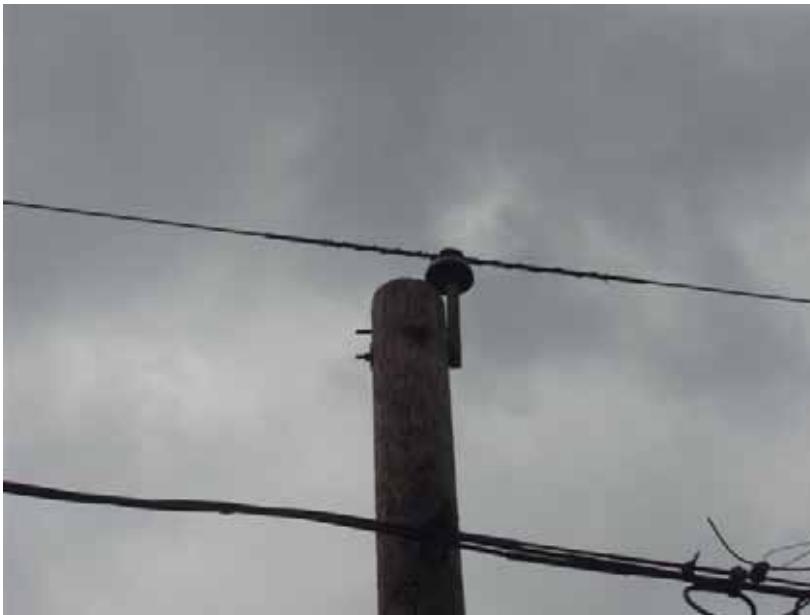
P6140047 – nut missing on top bolt

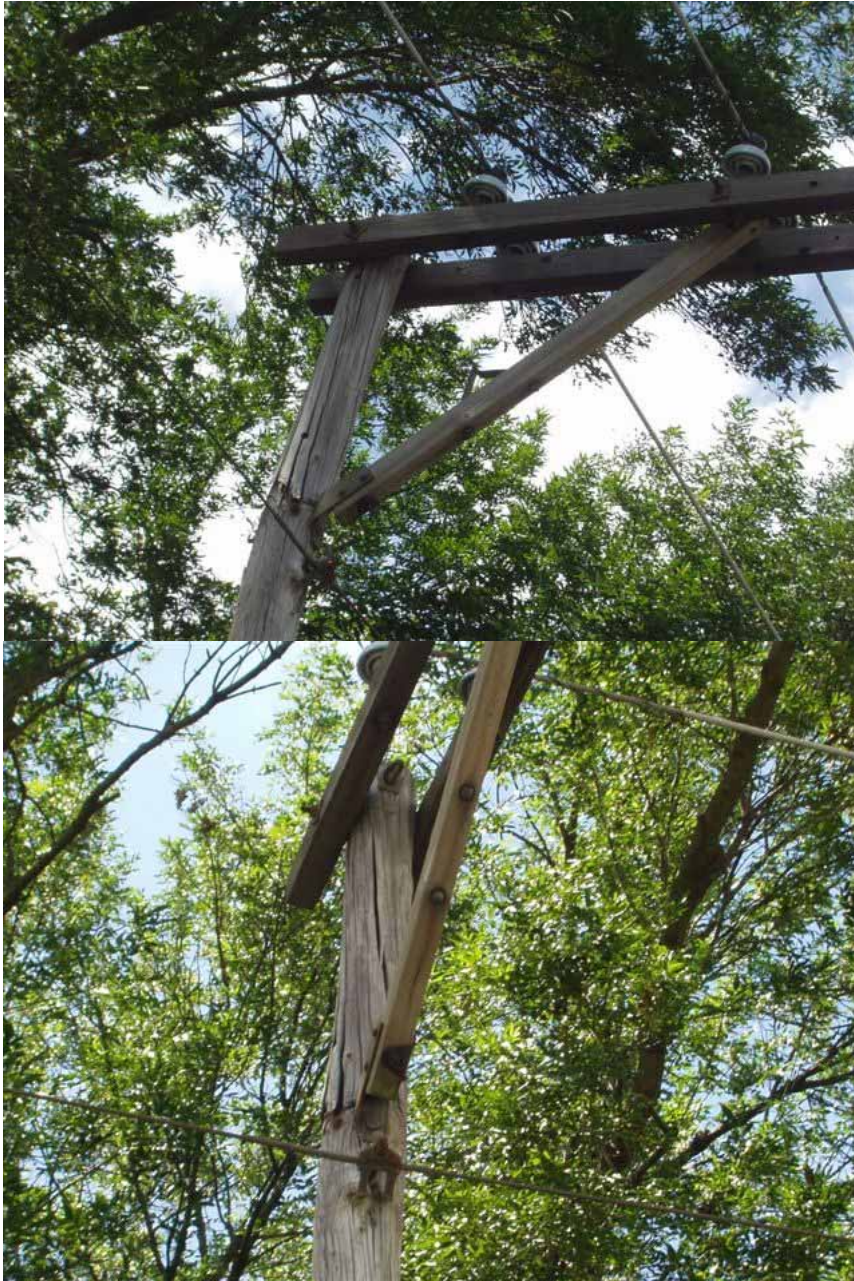
P6140050 & P6140051 – cracking of pole near top.

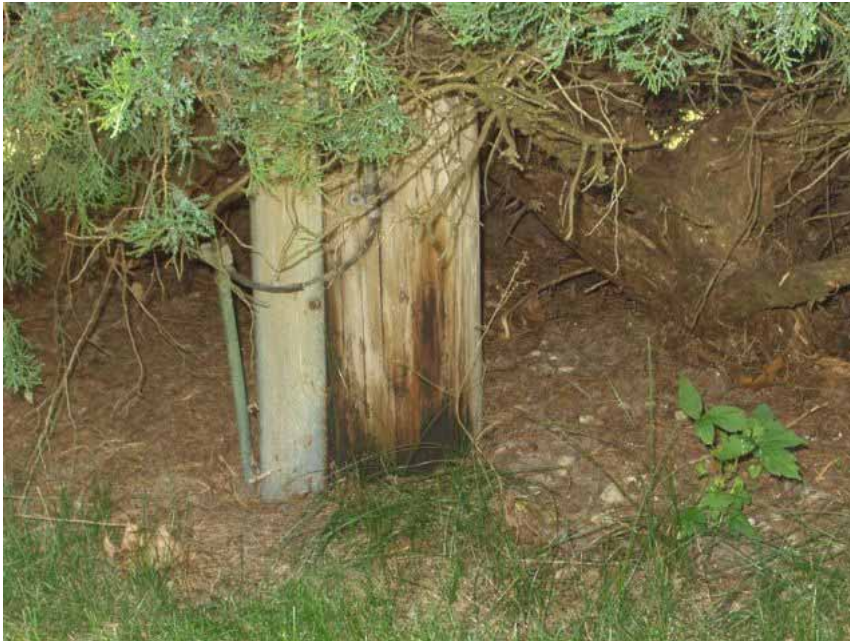
P6200004 – Ground cover/molding missing at bottom of pole and ground rod out of ground

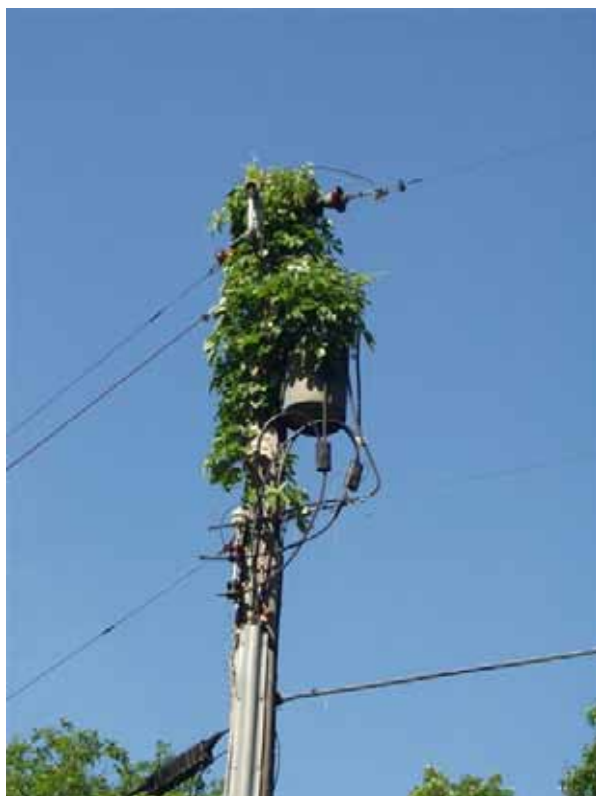
P6200008 -- Vine growing up inside molding and vine is on transformer. Ground guard bottom 4 feet is missing & exposing ground wire.

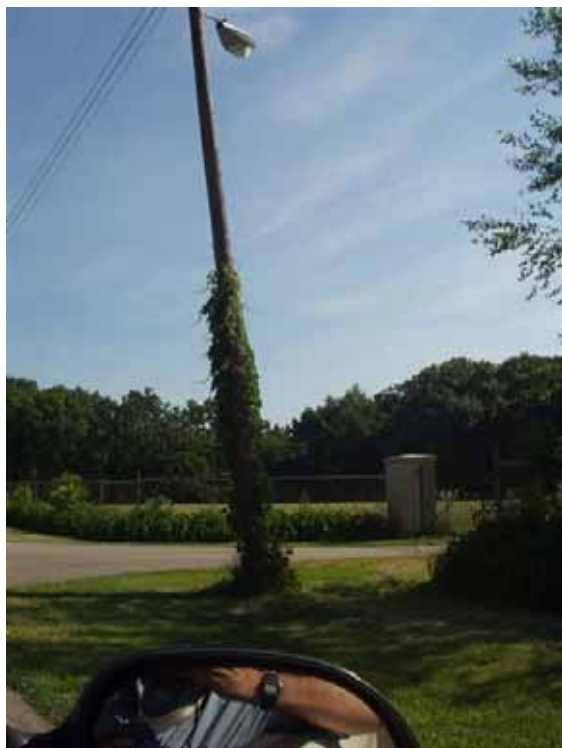
P62000010 – Vine growing on pole

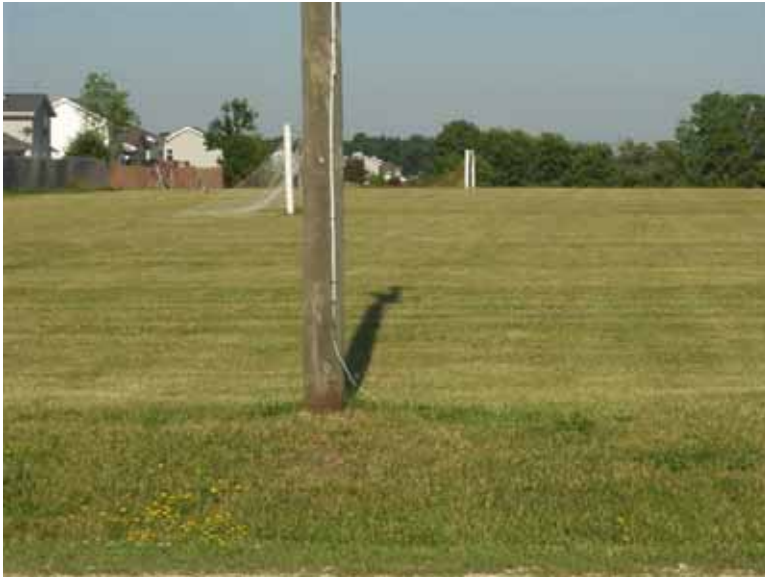
P6200006 -- Grounding wire down side of pole broken. Part of molding is missing.

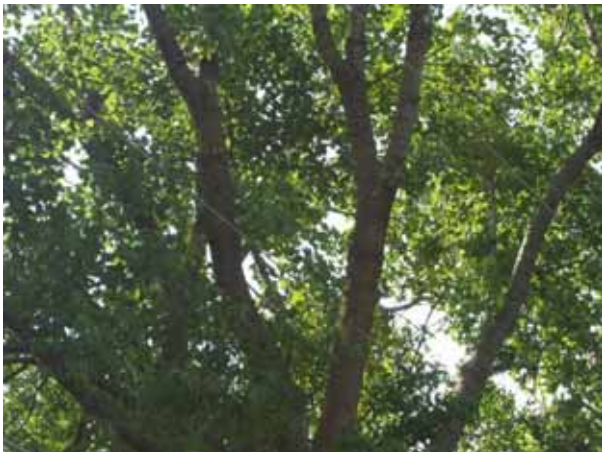
P6210025 – tree into primary with brown/burning marks at tips of branches

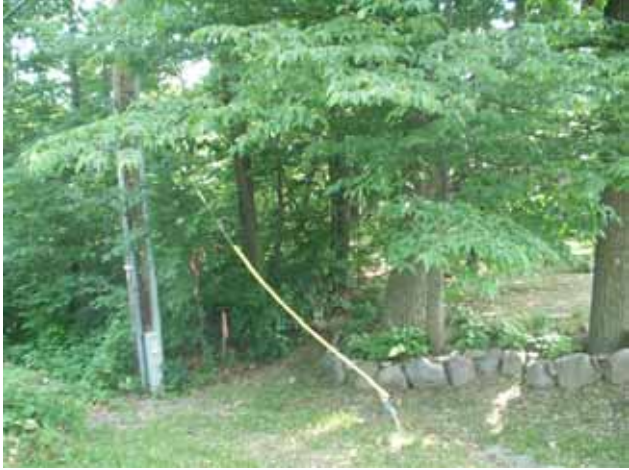
P6210026 – ComEd look out card left on side of pole & slack down guy.

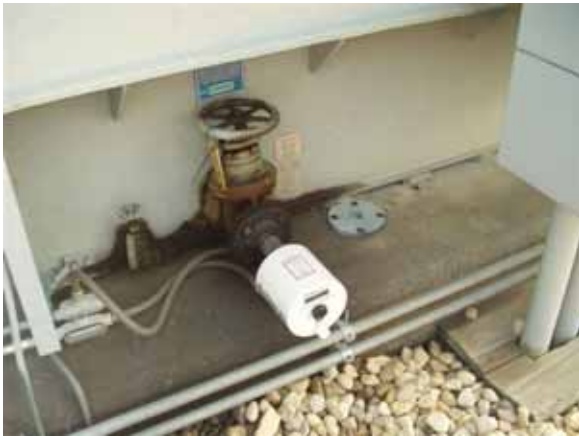
P6270005 -- Hydrant at TR 76 with some oil leakage or spillage

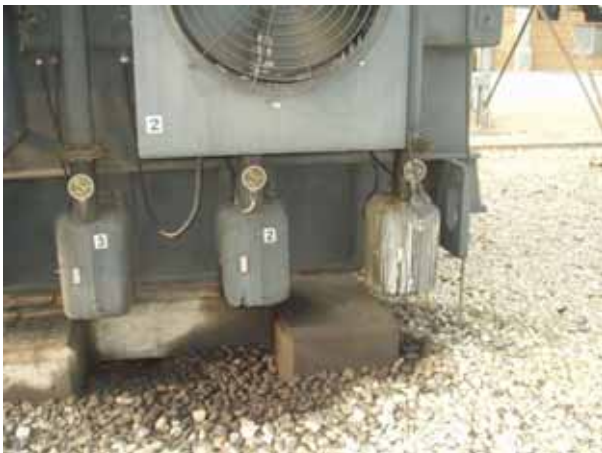
P6270008 – Fresh oil on ground at TR 77

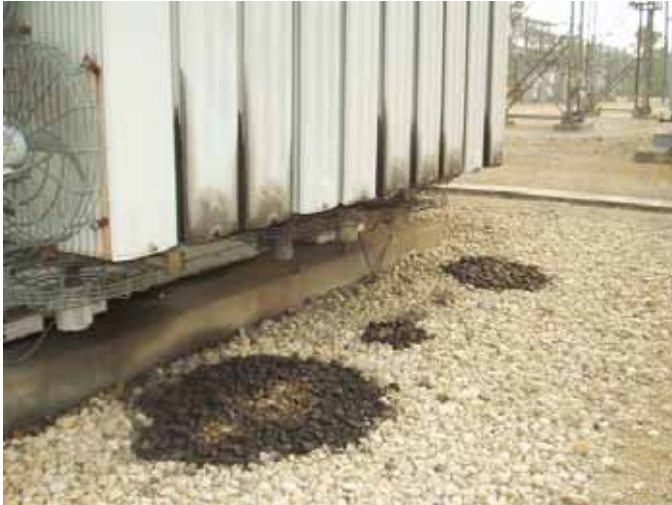
P6270012 – TR 74 old oil leaks below fins has not been cleaned up.

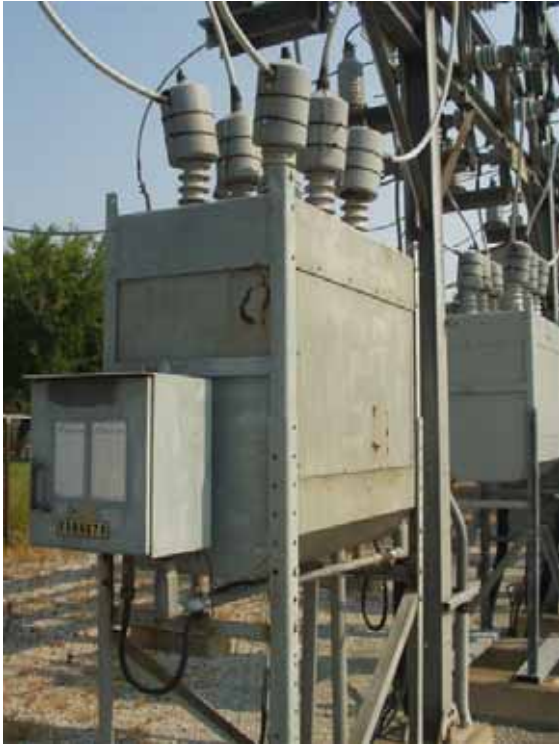
P6270026 – FDR4674 Bus Disc – with rust & bad paint job

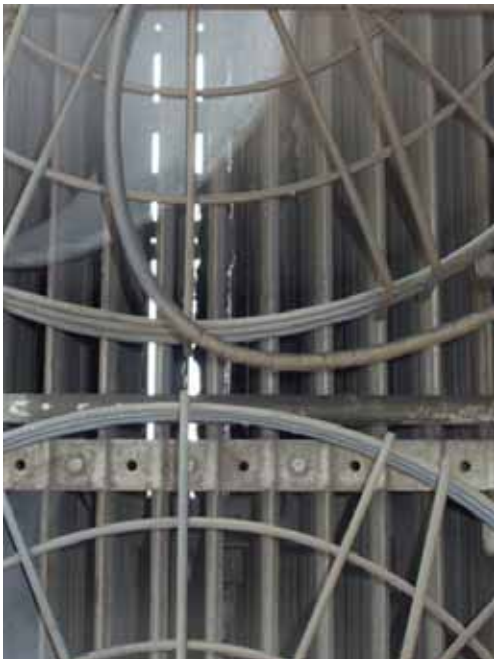
P6270031 – Dirt visible on cooling fins on transformer XFMR71

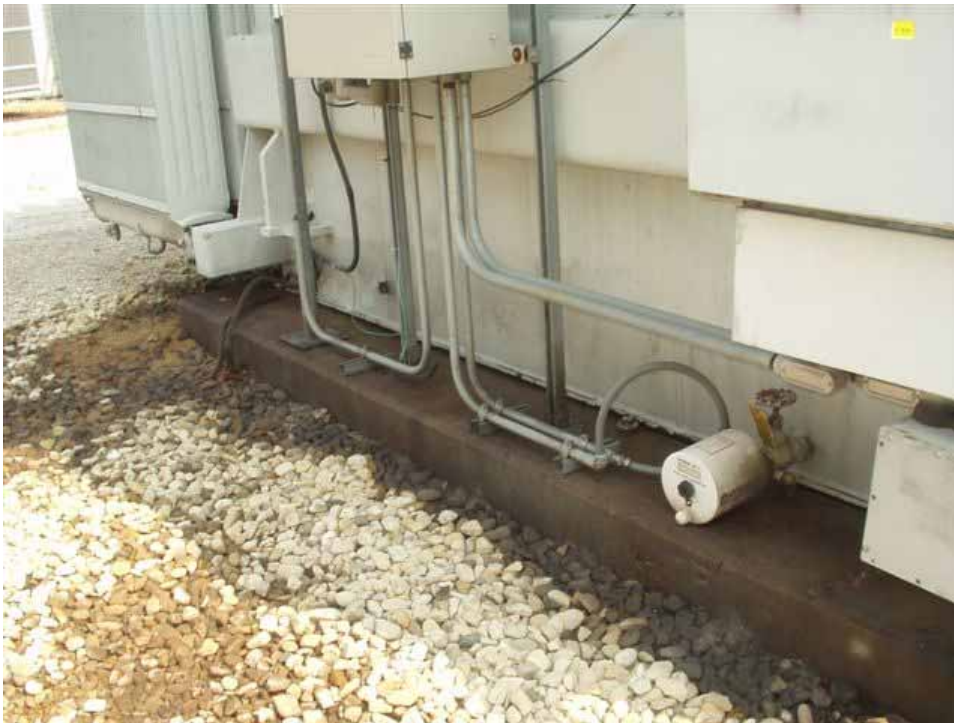
P6270036 – Leak on other side of XFMR 74. Noted ground cable partly out of ground

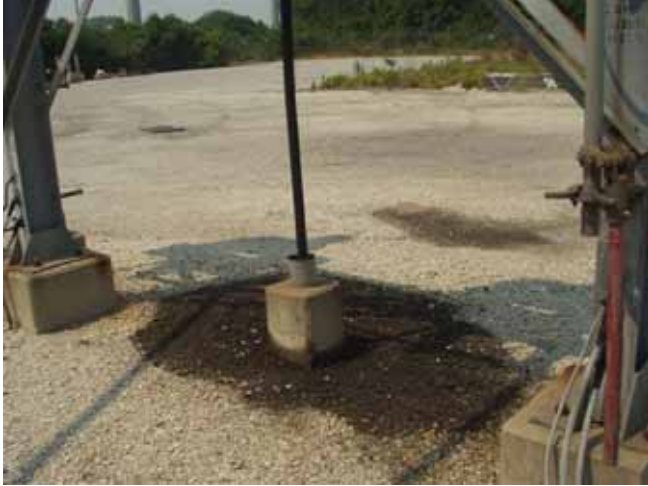
P6270040 – XFMR78 oil leak on ground from secondary cable

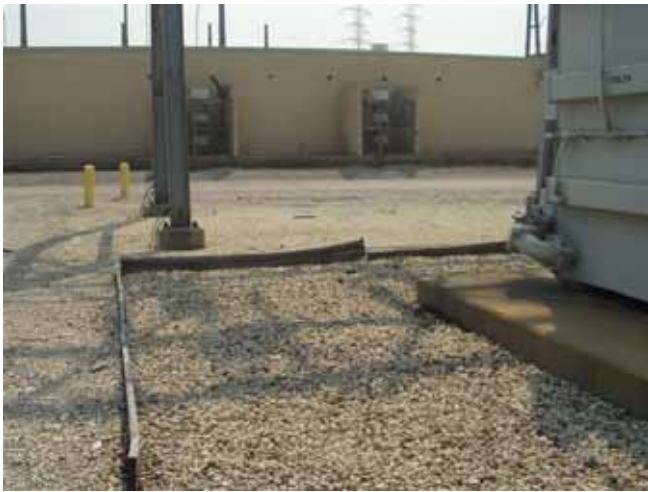
P6270041 – XFMR 78 tripping hazard.

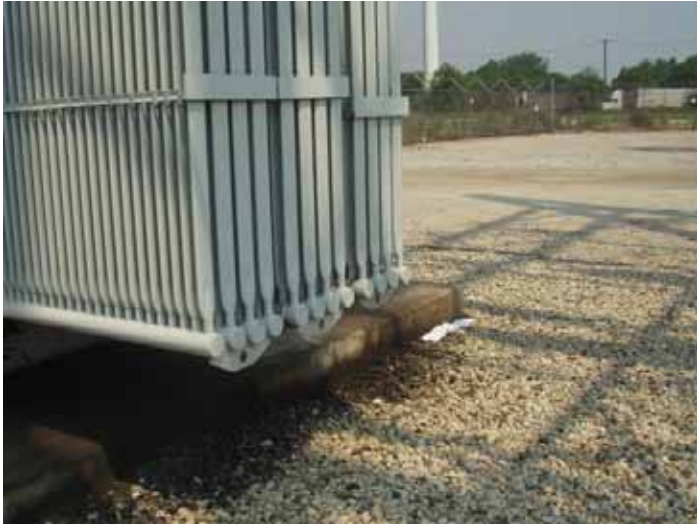
P6270043 – XFMR76 Trash around XFMR and oil stain.

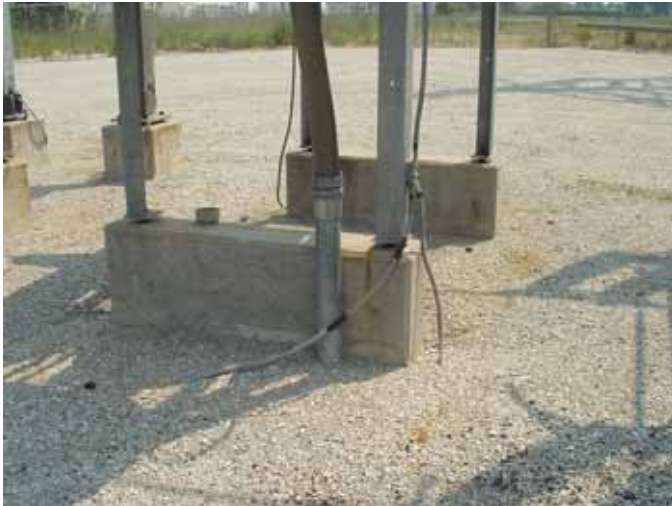
P6270046 – Ground wire laying on ground near L94402 Breaker

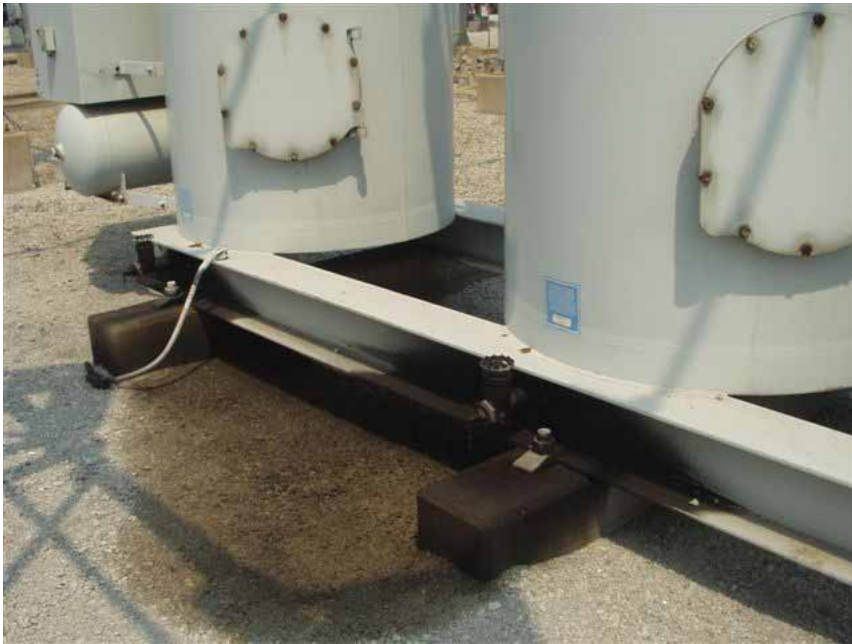
P6270051 – Oil leak at B&C phase tanks of BT2.3

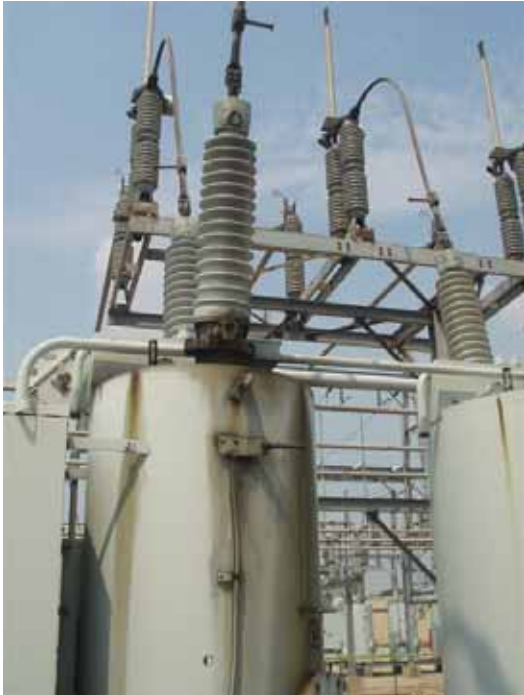
P6270053 – P.U. 33.34 C phase Tank bushing oil on “L” and oil leak visible == ComEd personnel noted that it is being decommissioned and is not currently in service

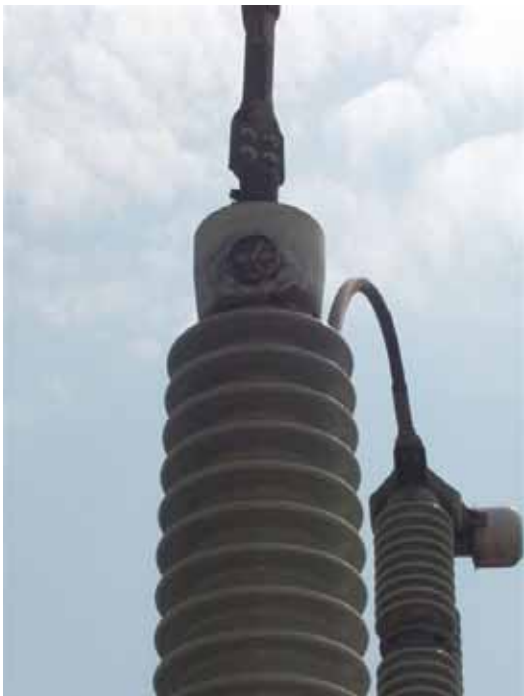
P6270055 – C phase bushing of L15001 OCB level on H

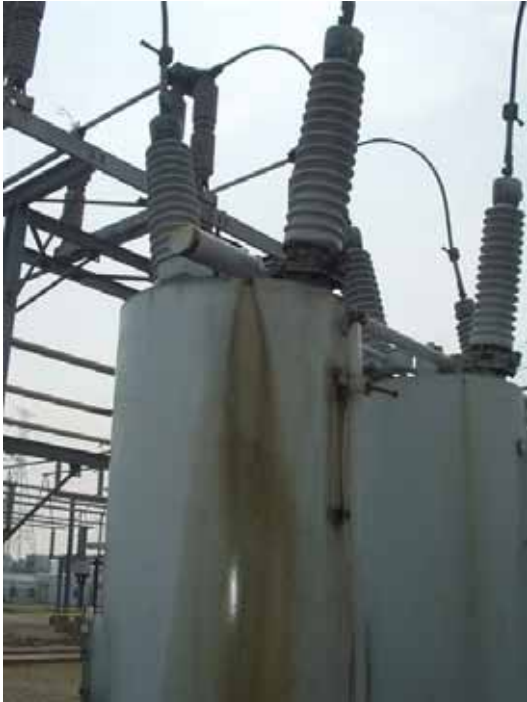
P6270057 – TR 72&76 OCB C phase tank active oil leak

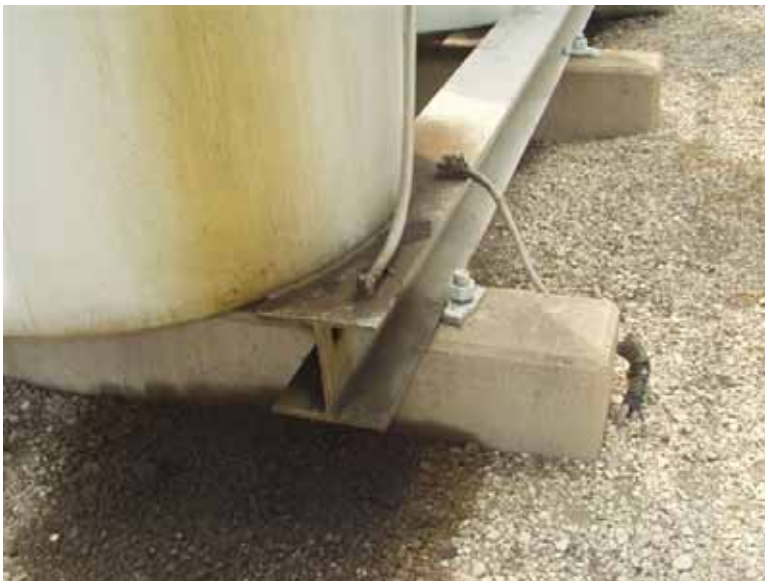
P6270059 – TR 72&76 OCB C phase anchor clamp off – all off on opposite side

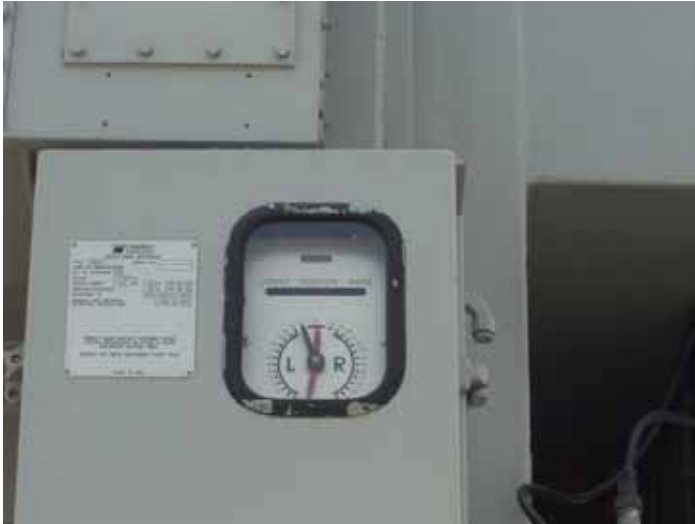
P6270061 – XFMR 71X LTC – noted operation at extreme limit.

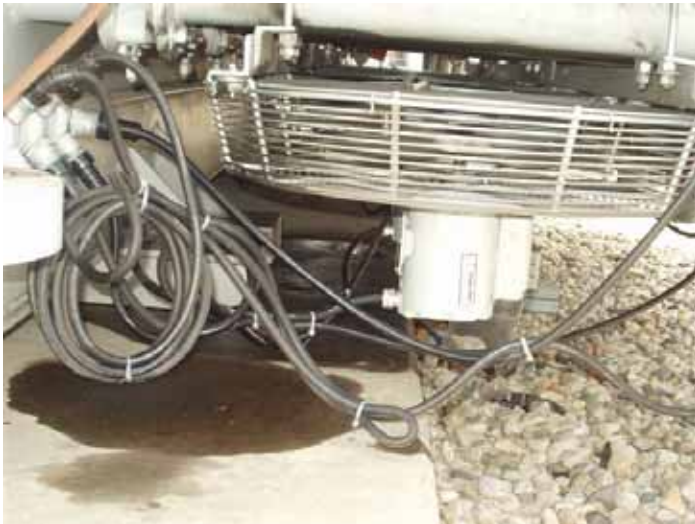
P6270062 – XFMR 71X oil leak under fins

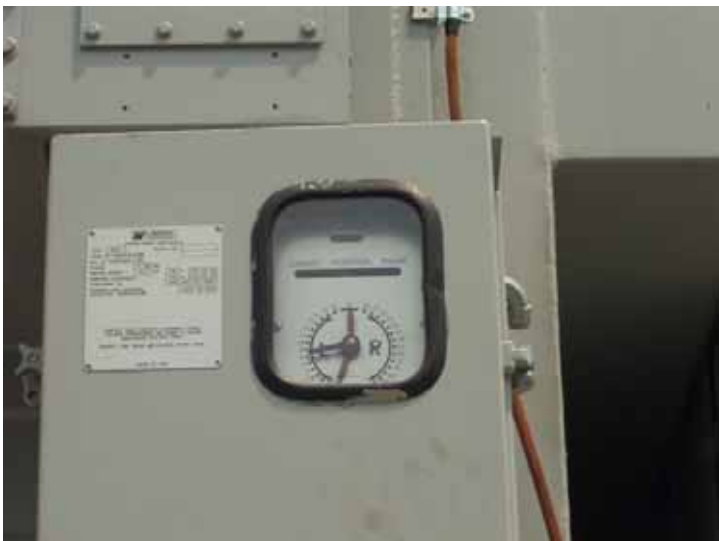
P6270063 – XFMR 71Y LTC – note operation at extreme limit

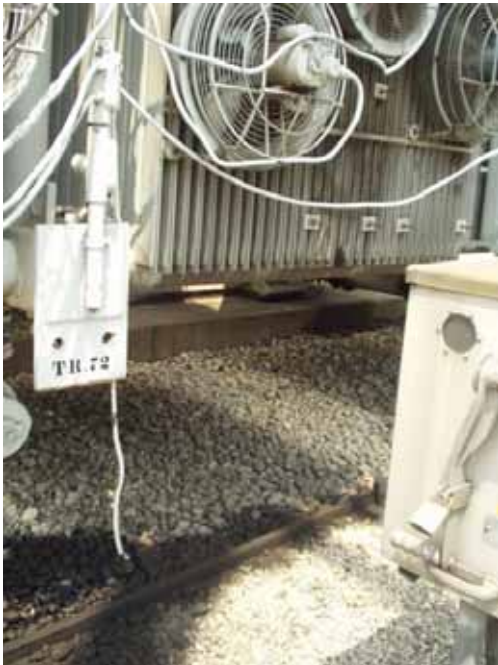
P6270065 – XFMR72 missing fan has been disconnected and is out for repairs

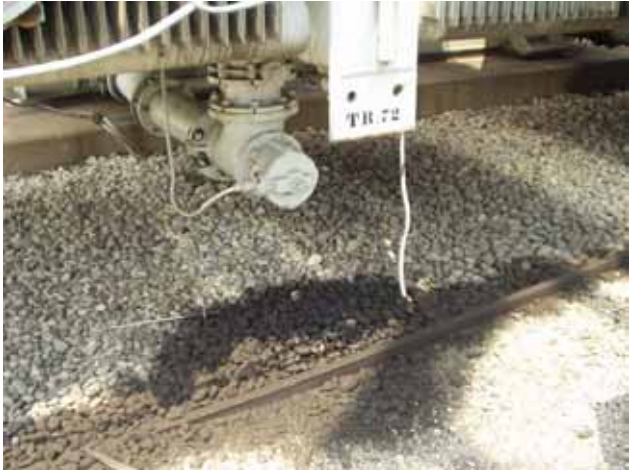
P6270066 – XFMR72 oil on ground

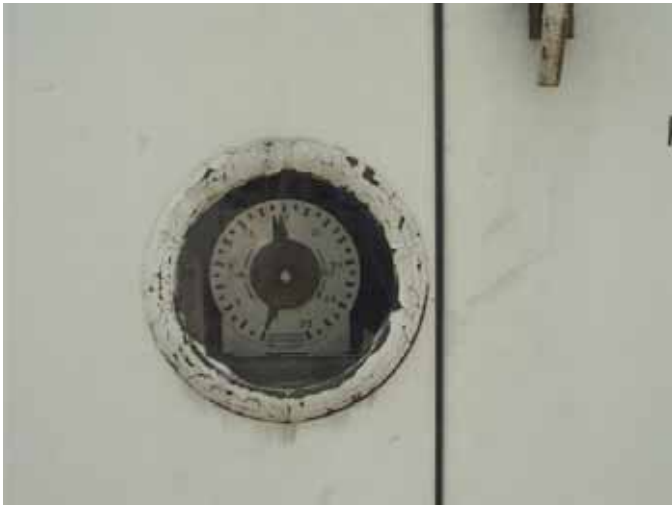
P6270068 – XFMR73X LTC shows that it has operated in one extreme position – XFMR also missing a fan that ComEd reports was removed for replacement

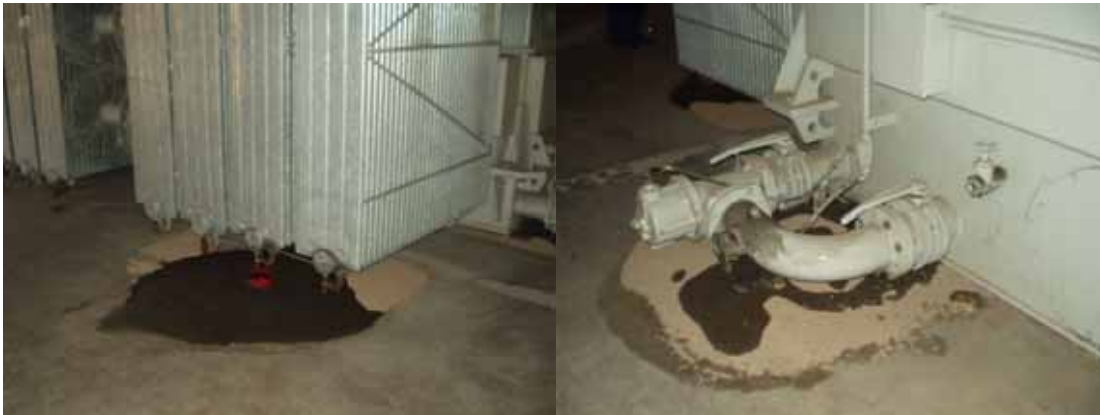
P6270076 & P6270077 XFMR73 oil leaks – note material placed down to absorb the oil for easier clean-up later

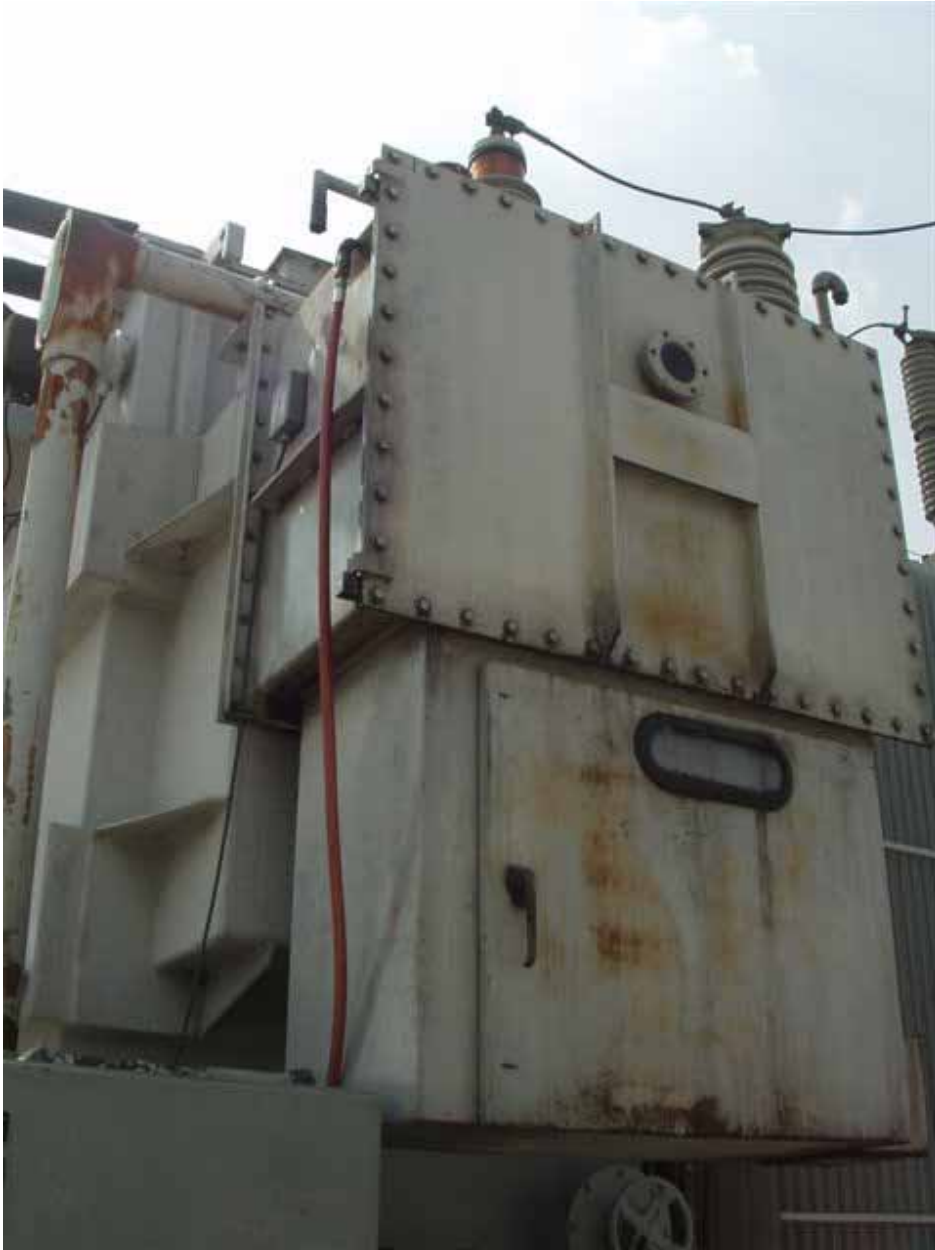
P6270084 – XFMR73: Oil coming out of vent – ComEd commented this was due to high oil levels and that the LTC had a leaking headboard.

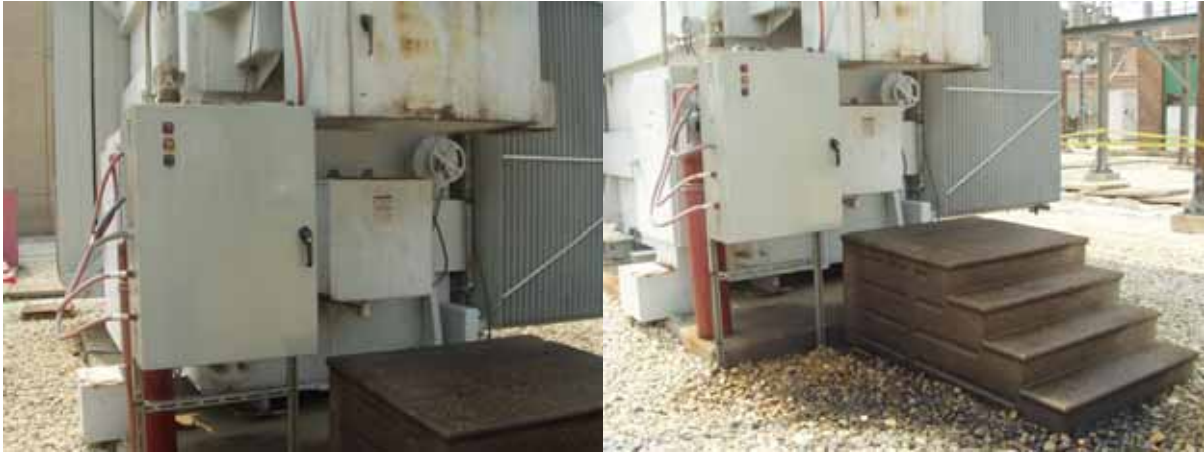
P6270085 & P6270086 -- XFMR73: oil from overflow onto cntl cabinet and onto ground and stairs – Staff was not able to check LTC position indicator without opening cabinet door because front was covered by oil obscuring view glass on door

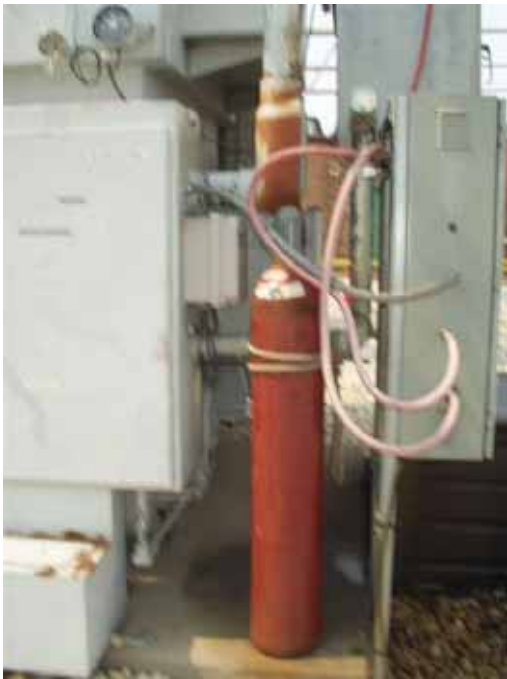
P6270087 XFMR73: cylinder held by rope and not chain

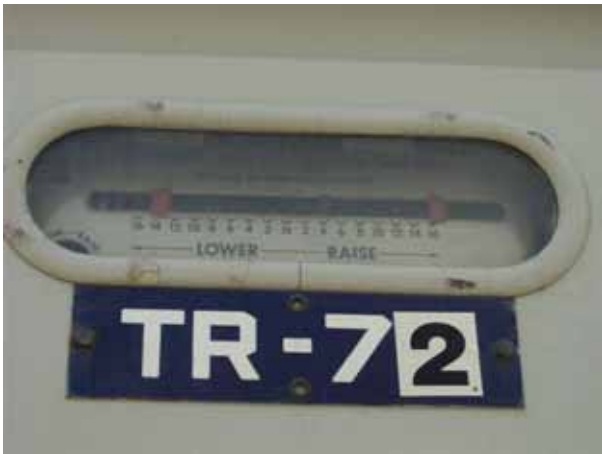
P6270090 – XFMR72 LTC range 13L to 16H

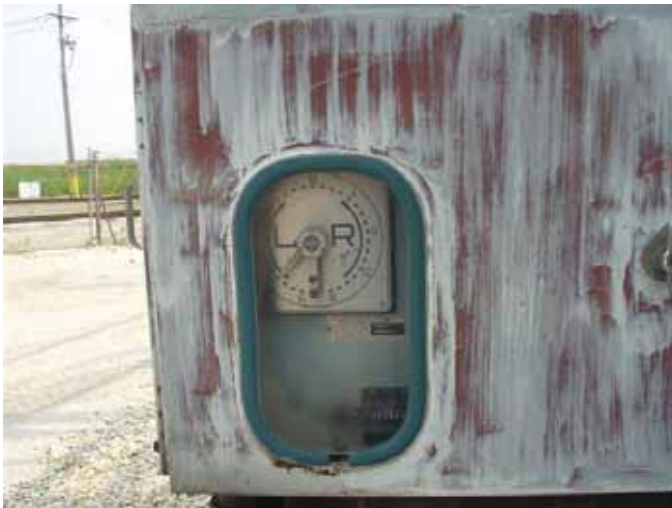
P6270093 – XFMR71 LTC – bad paint job on XFMR – old oil spill was also observed at XFMR71.

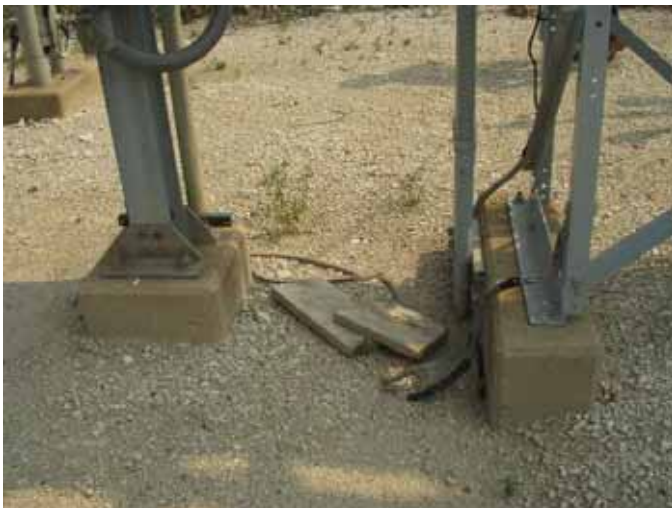
P6270096 – Ground cable laying on top of ground – trash and weeds in yard.

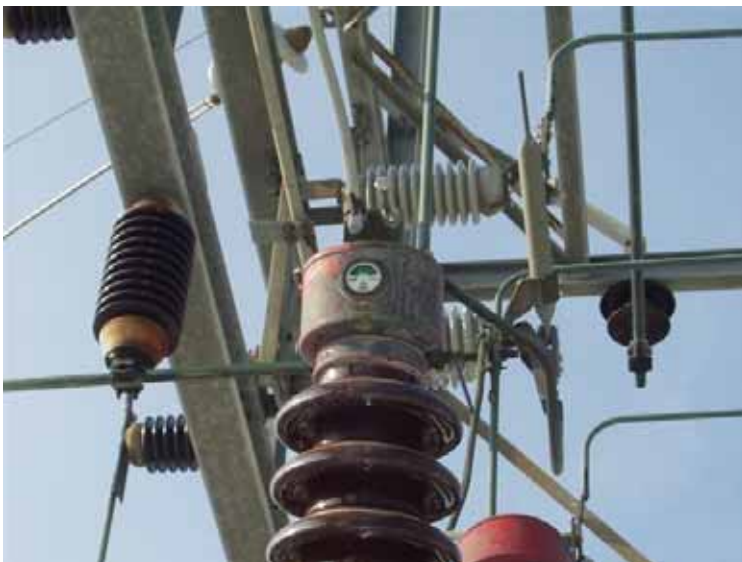
P6280104 – Arm on oil level gauge missing on POT & can't determine fluid level – ComEd personnel at substation said that POT is on W.O. order to replace on next PEG

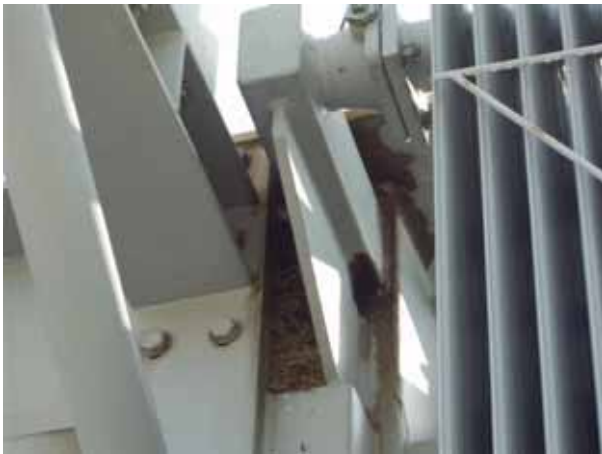
P6280107 – Bird nest in equipment [center of photo] and rust on equipment.

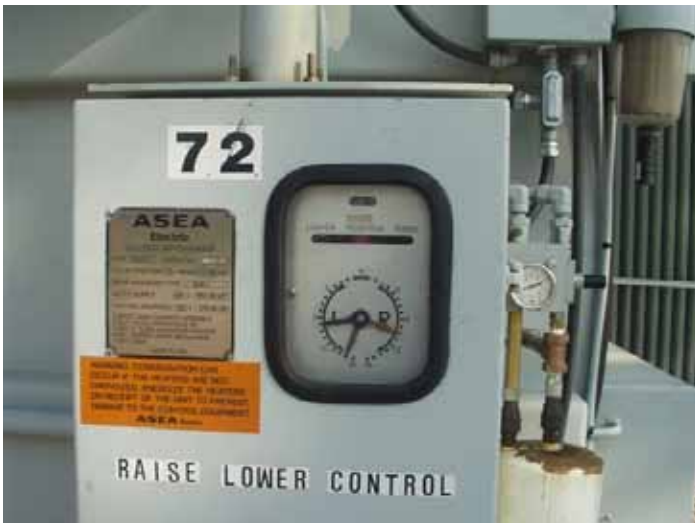
P6280108 – XFMR72 LTC shows operation at extreme lower limit. XFMR71 LTC was similar.

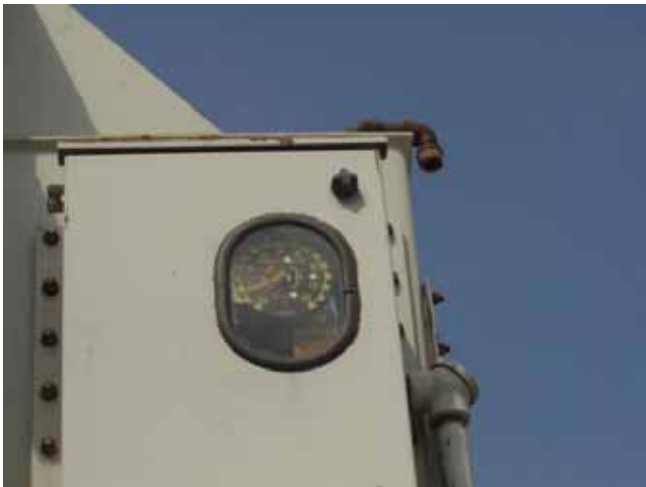
P6280122 – XFMR71 LTC – noted some oil on XFMR pad and in rock around XFMR

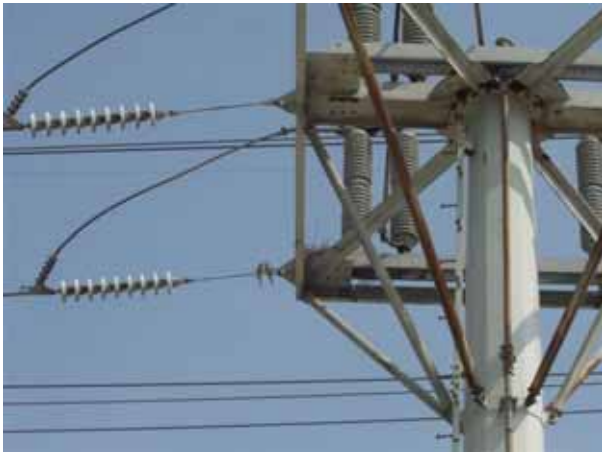
P6280126 – Two+ Monk Parakeet's and nest on transmission tower located in substation

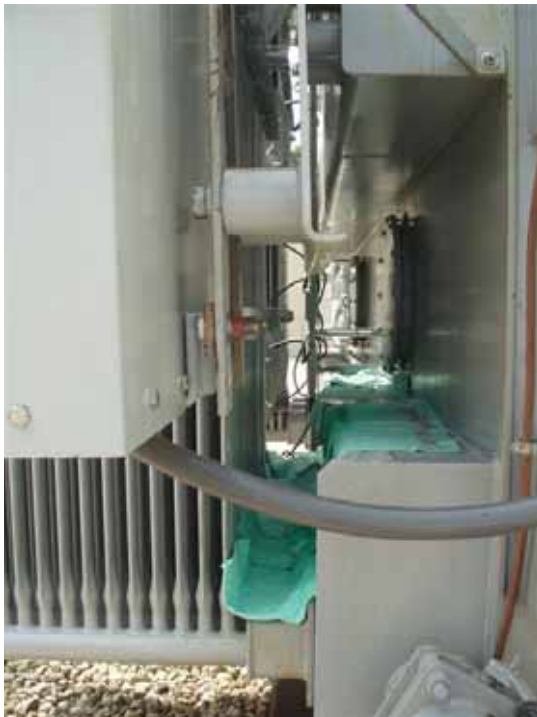
P6280133 – XFMR71 oil leak on fins – note absorbent material placed to capture leaking fluids making for easier cleanup later.

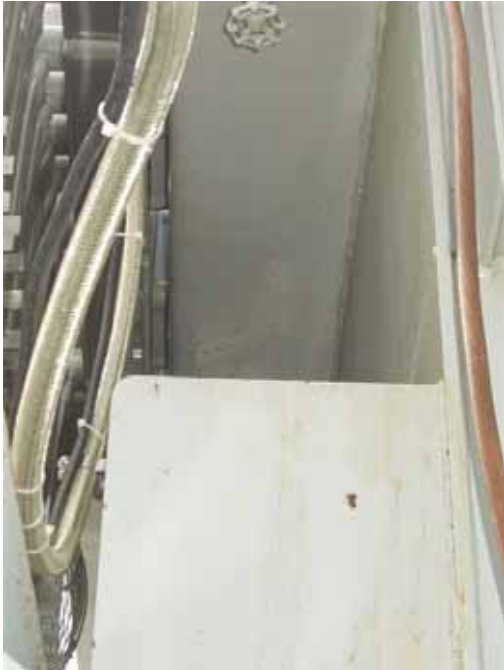
P6280134 – XFMR71 oil leak on fins
